Should Someone Call a Plumber?

Enrico Stradiotto, P.Eng.

OCPA, Technical Resources Engineer

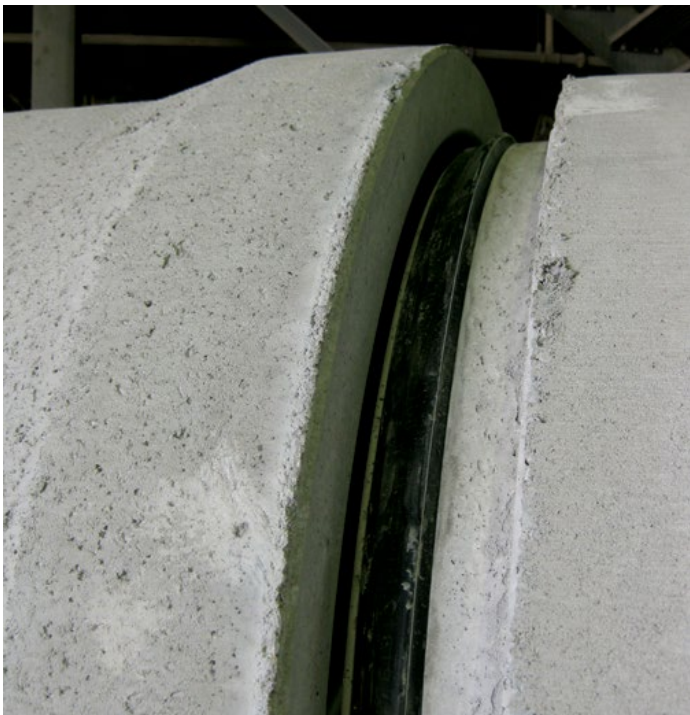
Concrete pipe joint with rubber gasket

provides watertight performance by using rubber gaskets in its joints.

PURPOSE: The obvious...it's not what the owner paid for. A leak in a sewer pipe is an opportunity for groundwater to infiltrate into the sewer system, or, for sewer flow to exfiltrate from the pipe into the ground. A quality pipe with watertight joints will provide the desired performance. Reinforced concrete pipe (RCP)

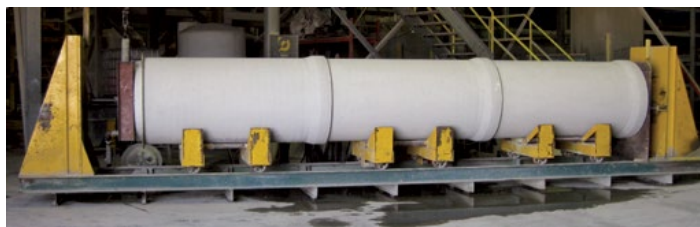
Hydrostatic test of concrete pipe

Hydrostatic testing of concrete pipe under the PPP includes the following parts:

1. Test assembly includes three different pipe setups, consisting of three pipe in-line with gaskets,
 - a. Straight alignment;
 - b. Deflected joints to simulate pipe misalignment in the field;
 - c. Pipe with Differential Load to simulate loss of support for the pipe length in the field.
2. Test pressure is 103 kPa (15 psi), with reduced pressures for the Deflected Test and the Differential Load Test.

3. Frequency of testing is a minimum of once every six months, with conditions based on quantity of pipe produced, and/or last production date.
4. A successful pass is given when there is no visible leak of water from the joint area or through the pipe wall, while under the hydrostatic test pressure for a 10 minute duration.
5. A failure in a test requires retesting of pipe within the same production run, with the new requirement of two successful tests for every single test that has failed. A continued failure of pipe will require all pipes in the production run to be segregated.
6. **Note:** Hydrostatic testing is also done for 1200mm diameter precast maintenance holes in a vertical setup.

The hydrostatic performance of RCP is verified by tests done at the manufacturing plant according to the Plant Prequalification Program (PPP). The PPP ensures RCP will meet the hydrostatic requirements specified in CSA A257.2 for concrete pipe with rubber gasket joints. Certification under the PPP then provides the engineer the assurance that a watertight and certified concrete pipe product is on site.
