This Could Easily Happen in Ontario!

Gerry Mulhern, P.Eng.
Executive Director – OCPA

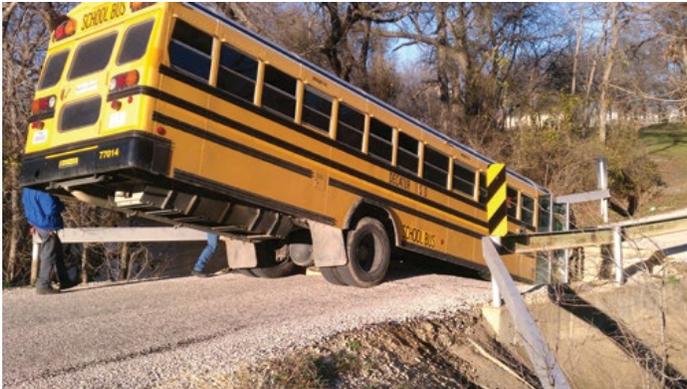
*A school bus in a crater caused by a collapsed corrugated steel pipe
photo credit: Dustin Hood*

A corrugated steel pipe collapsed under the weight of a school bus in Rhome, Texas on Thursday January 26th, leaving the bus stuck with its rear in the air. Only four of the day's 63 passengers were still on board at the time and the driver was able to get those students evacuated with no injuries.

The area had received approximately 150mm of rain in a thirty six hour period preceding the corrugated steel pipe collapse and it is speculated that this rainfall washed away much of the pipe's soil support. The bus driver stopped the bus short of the culvert and then stopped again after her front wheels rolled over the culvert and immediately started to sink.

"The main thing is no one was hurt," White said. "Everything else can be put back as good as it was or better than it was." The commissioner said the narrow, one-lane crossing will be replaced by a 24-foot, two-lane bridge 53 feet in length.

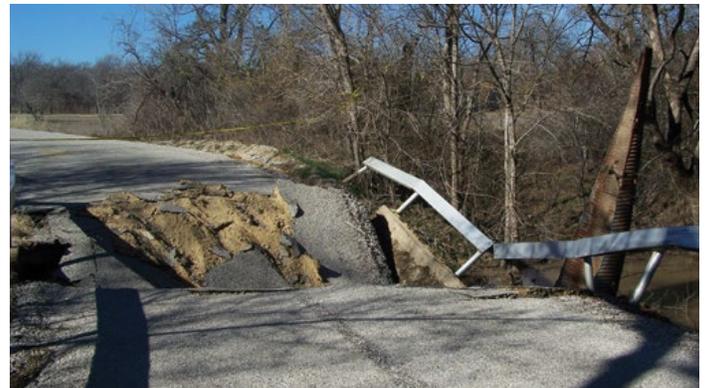
*Crater caused by the corrugated steel pipe failure
A section of the CSP is visible on the right hand side
of the picture projecting vertically
photo credit: John Dutschmann, Technical Resource Manager
Hanson Pipe and Precast*

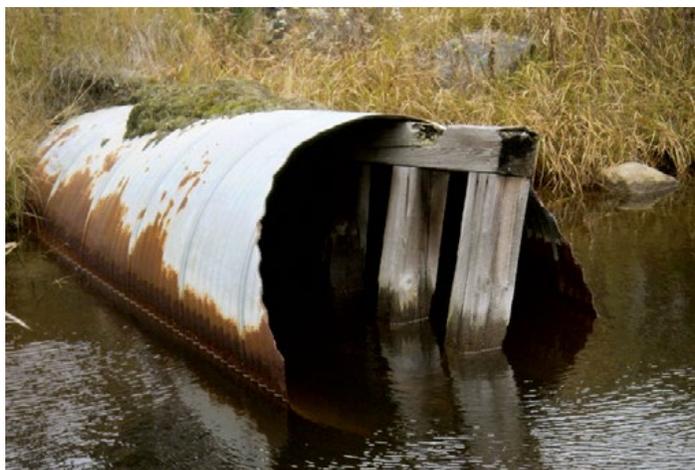
Deteriorated culverts under Trans Canada Highway
